Stawell Gold Mines

Environment Review Committee Minutes

11 February 2025

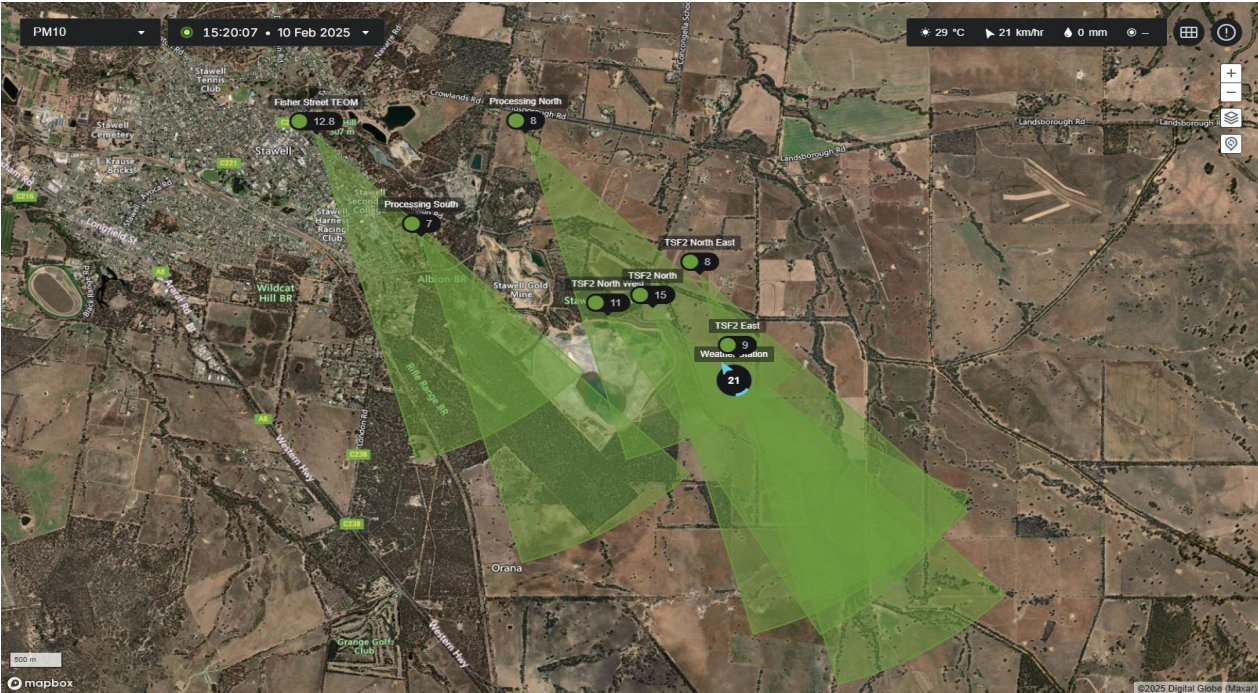
Figure 1: Real Time Air Quality Monitoring Map

All mine related emissions were within their respective 24h guidance values for PM_{2.5} and PM₁₀. Spikes in readings (see figure 2 and 3) were caused by bushfire activity in the Grampians National Park.

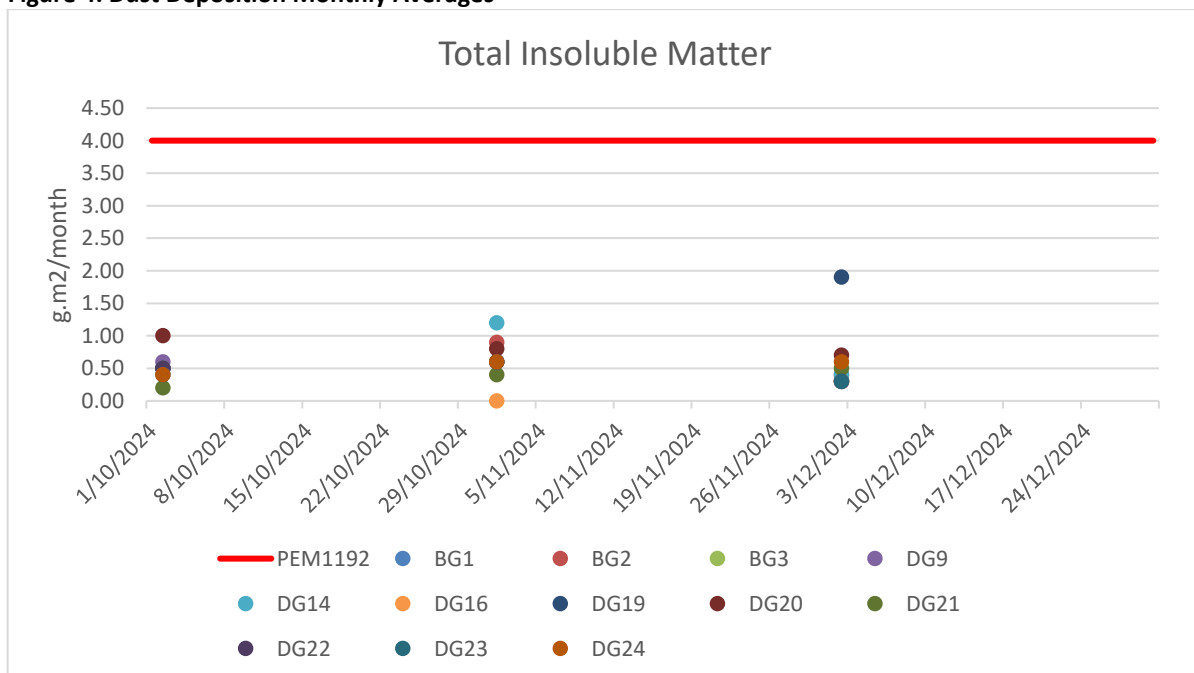
Figure 4. Dust Deposition Monthly Averages

Dust deposition results showed one elevated reading in DG19. The contamination was caused by Christmas Beetles. In responding to a question SGM noted that on average, around 1.5 of the 12 dust gauges would be contaminated each month. The real time air quality monitors are obviously the most effective tool for monitoring air quality and responding in a timely fashion. The gauges that are collected on a monthly basis form part of compliance measures and help build an understanding of the overall patterns over time.

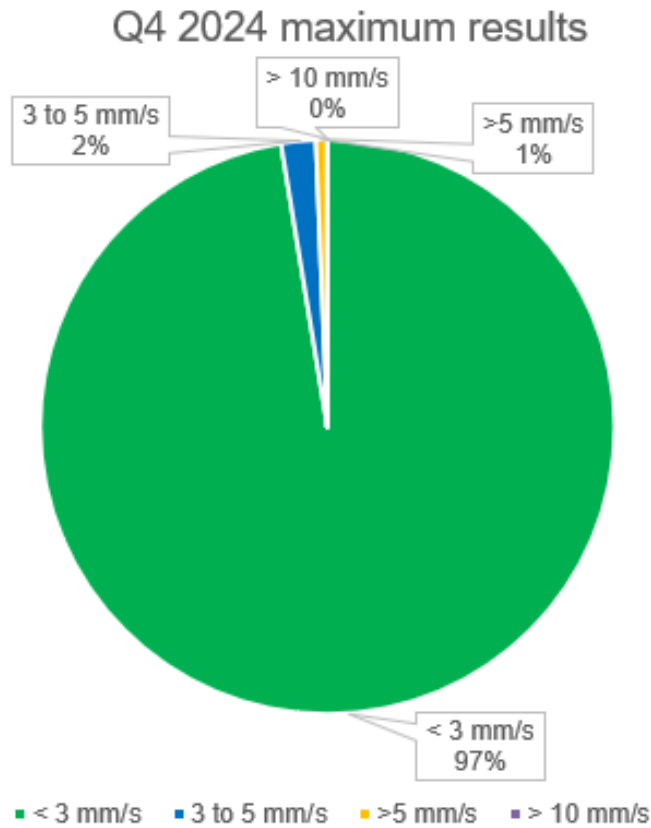
Figure 6. Vibration Results (1/10/24 – 31/12/2024)

All readings were below the 10mm/sec absolute limit requirements.

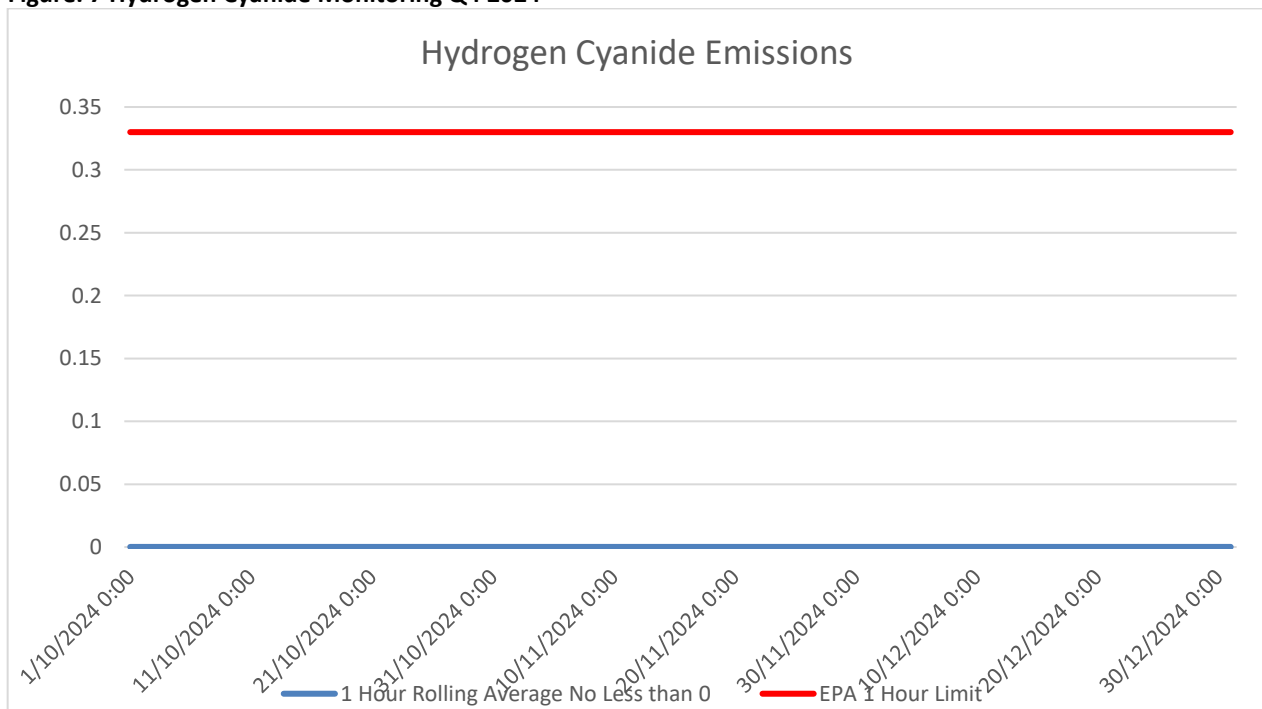
Figure. 7 Hydrogen Cyanide Monitoring Q4 2024

SGM's Hydrogen Cyanide readings showed no detections throughout the monitoring period.
